# International Space Station Li-ion Battery Change-out Experience Through 2021

SPACE POWER WORKSHOP

19 APRIL 2021

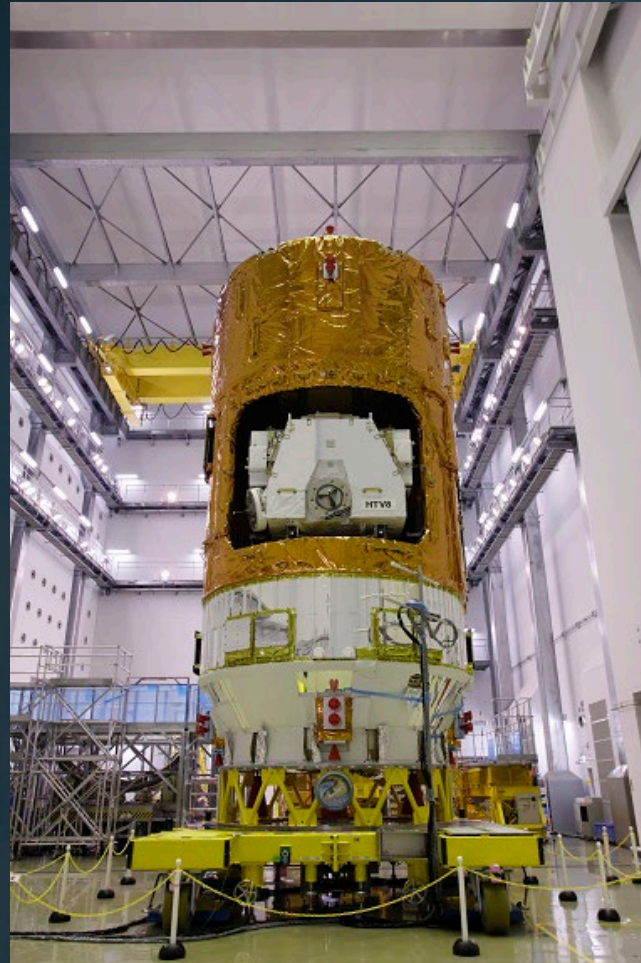
- ▶ Ship batteries and adapter plates to Tanegashima Space Center, Japan
- ▶ Install on HTV External Pallet (EP)
- ▶ Fully charge batteries prior to launch

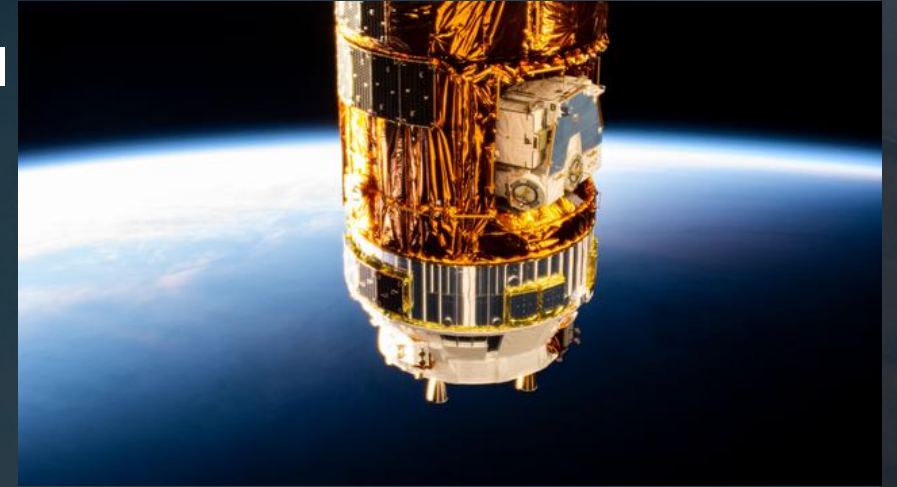
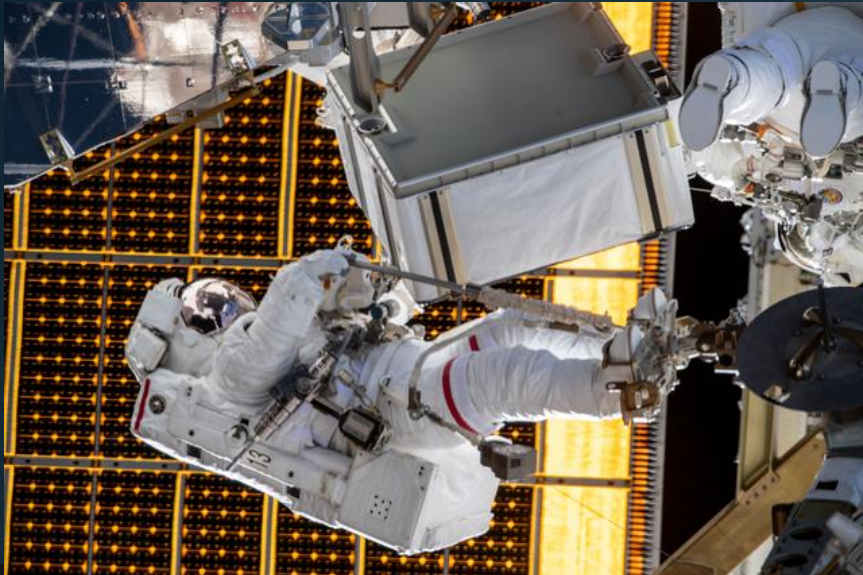
- ▶ Seamless Power Channel Handover (SPCH) of the channel
  - ▶ Draining the existing  $\text{NiH}_2$  batteries
  - ▶ Reduce loads on supporting channel
- ▶ Robotic prep work
  - ▶ Extract external pallet from HTV, position near work site
  - ▶ Use Special Purpose Dexterous Manipulator (SPDM) to install batteries for inboard channels (P4, S4)
  - ▶ Robotic Arm / SPDM cannot reach outboard channels (P6, S6)

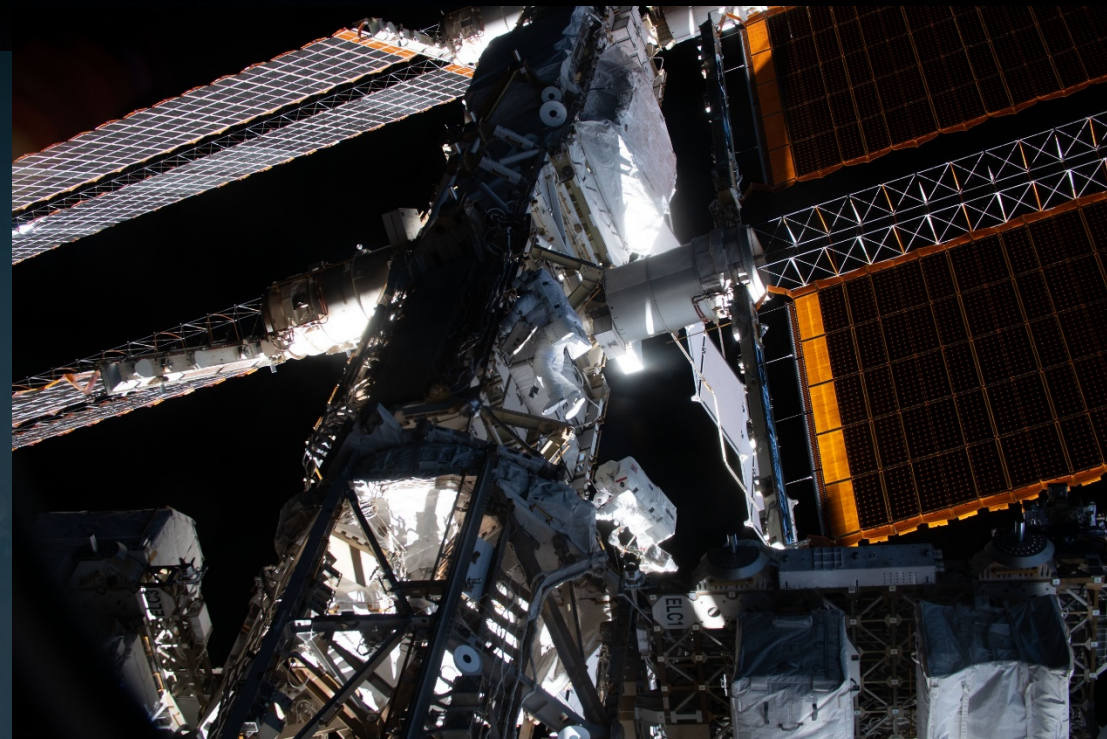
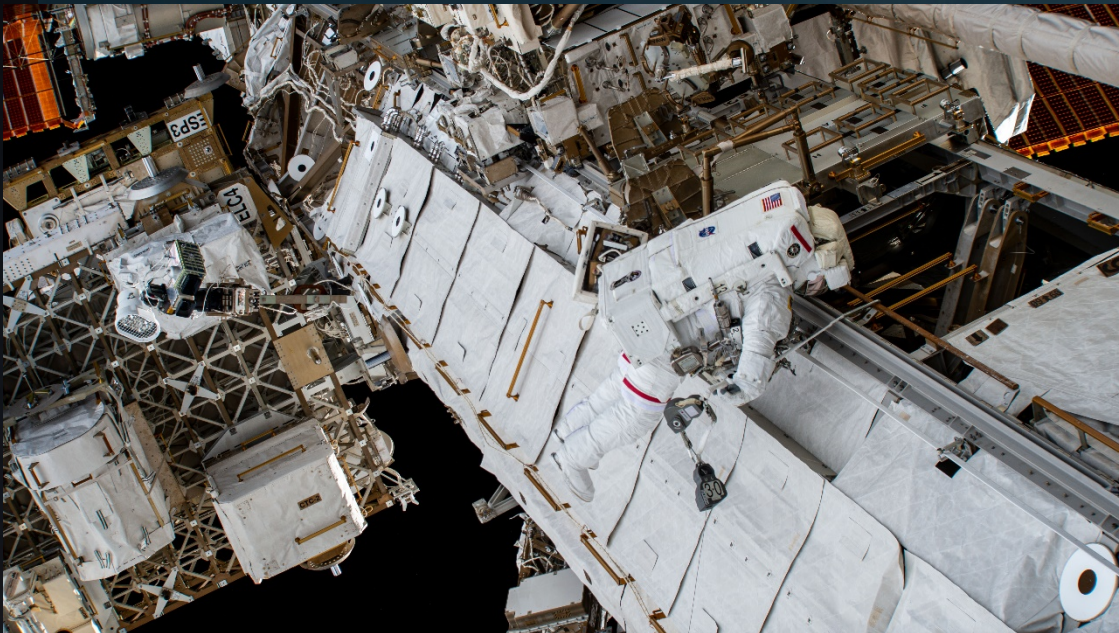
- ▶ 4A3 BCDU tried to start up 4A3 Li-ion battery
  - ▶ Low temperature and low 1A current caused “stall” condition in the BCDU
  - ▶ “Stall” condition on degraded BCDU diode led to diode failure
  - ▶ Failed diode in BCDU Fault Isolator caused blown fuse in the new 4A3 Li-ion battery

- ▶ BCDU replaced with on-orbit spare
  - ▶ Replaced failed Li-ion battery with old NiH<sub>2</sub> battery
    - ▶ If left at 2 batteries, use reduced peak power limit
    - ▶ Therefore decision to reinstall NiH<sub>2</sub> battery
  - ▶ Resulted in mixed chemistry channel, 2 Li-ion batteries, 2 NiH<sub>2</sub> ORUs, from Sep 2018 to Feb 2021

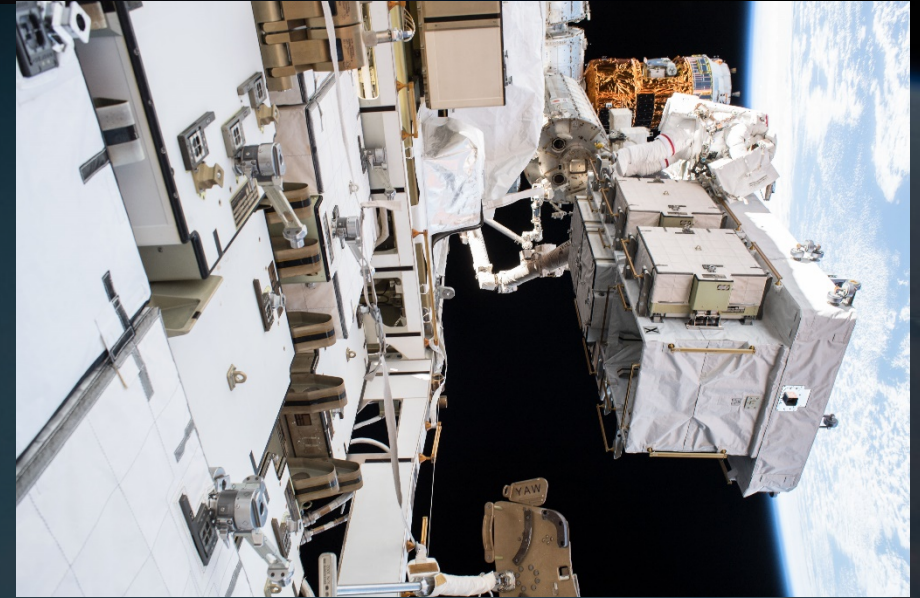
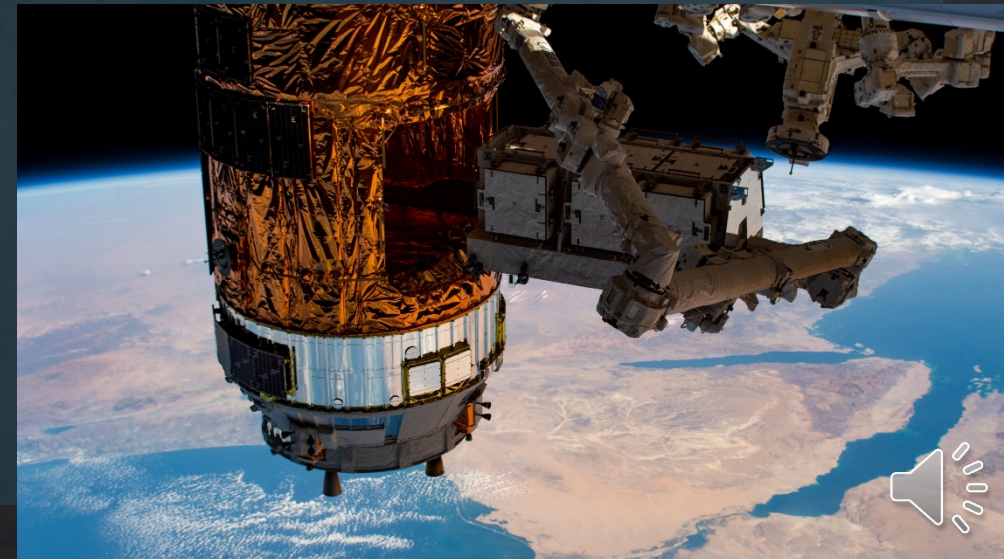
## 2B: Multiple Crew EVAs

- ▶ HTV8 brings up next set of Li-ion batteries in Sep 2019
  - ▶ First installations on outboard channels (P6). Robotic appendages cannot reach these locations. All work must be performed by EVA crew
  - ▶ Planners unsure how many EVAs it will take to change out batteries
  - ▶ Considerations made to determine if a hybrid EVA would be necessary. Each channel would get two dedicated EVAs and half of another EVA (i.e. 5 total EVAs for two channels)
  - ▶ Transition for first channel, 2B, is completed in two EVAs

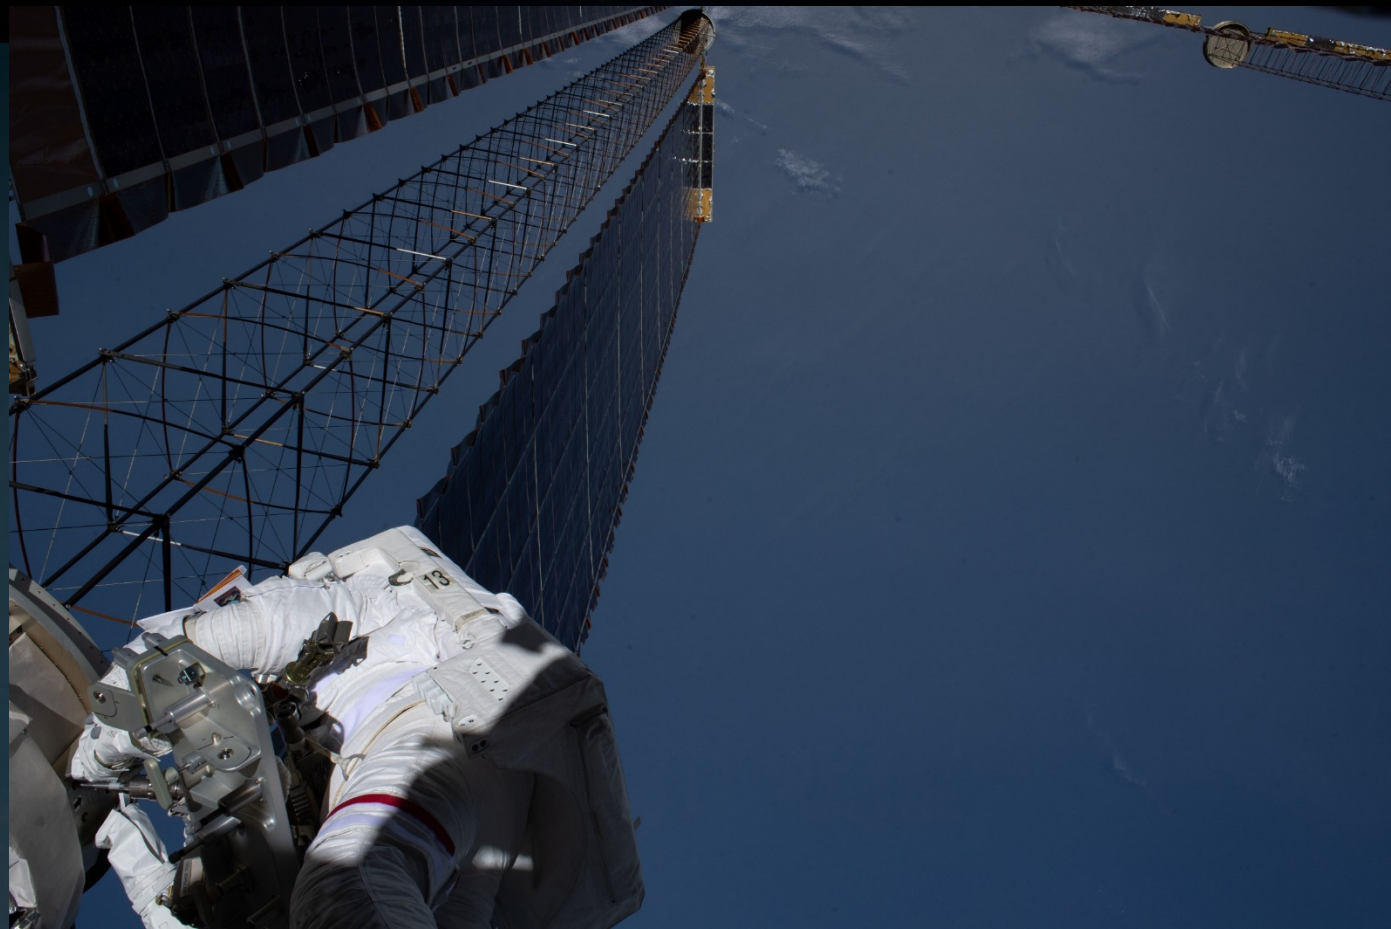
- ▶ After 2B Li-ion battery installation, 2B2 BCDU failed to power up
  - ▶ Again, low temperature, low current start up caused BCDU “stall” condition
  - ▶ 2B2 Li-ion battery not impacted
- ▶ Replaced 2B2 BCDU with on-orbit spare
  - ▶ Success: 2B - 3 operational Li-ion batteries
  - ▶ 2B2 BCDU returned to the ground for investigation, recertified for flight
- ▶ Delay 4B Li-ion battery replacement to better understand BCDU issues
  - ▶ All battery capacity testing temporarily halted
  - ▶ 2 on-orbit BCDU spares left
- ▶ **BCDUs are currently 10 – 20 years old.**

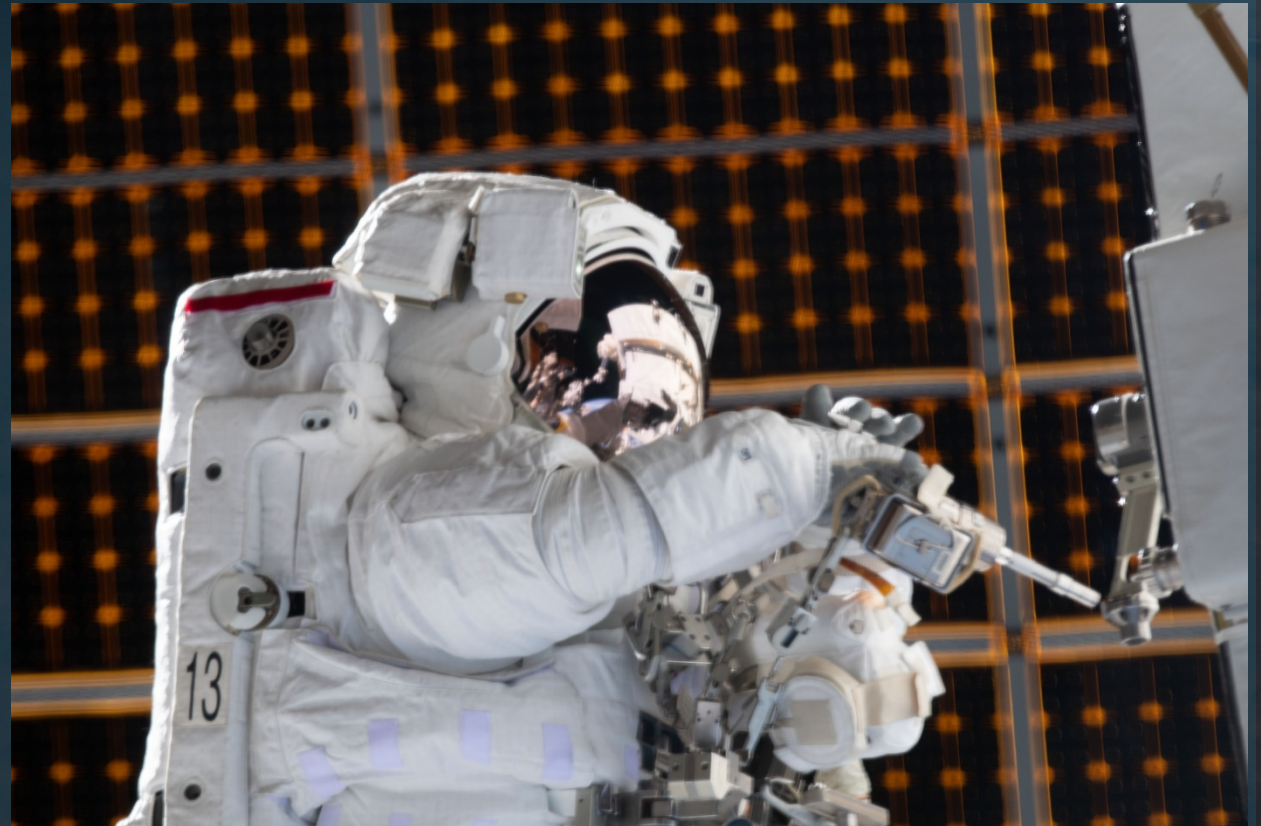
# 4B: Modified Start Up

- ▶ Battery installations continue
  - ▶ Incorporated new start up procedure – 10 amp and  $-5^{\circ}\text{C}$  on BCDUs (previous failures had been at 1 amp,  $-17^{\circ}\text{C}$ )
  - ▶ Second channel on P6 completes transition to Li-ion batteries in two EVAs
  - ▶ No failures occur. ISS teams breathe a big sigh of relief
