Radiation Damage and Annealing Recovery

Test Protocol and Samples/ Temperature Profiles

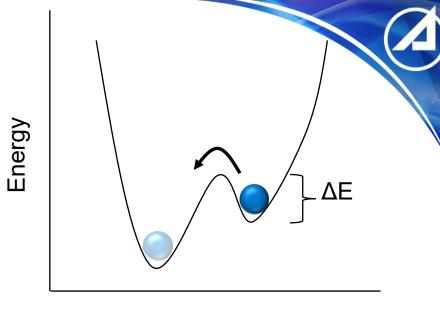
- Charged particle irradiation causes a variety of defects in space-based PVCs
- <u>Thermal Annealing</u>: The removal or rearrangement of defects when a material is exposed to elevated temperatures
 - 1. Can provide insight into presence of high and low energy defects
 - 2. Critical for predicting on-orbit solar array performance

Fluence (particles/cm²)

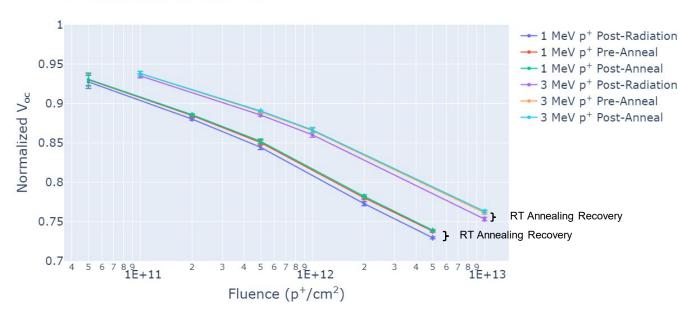
Normalized V_{oc} : 3J Solar Cell.

- For III-V cells, annealing recovery is small
 - Close to bounds of measurement error
- RT annealing can produce a significant portion of this recovery
 - Suggests presence of low energy defects

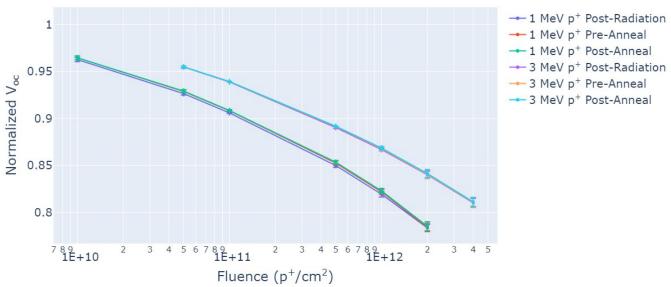
Normalized Voc: 3J Solar Cell. 6 Month Delay in Post-Radiation LIV

- To properly document the effects of HT annealing:
 - Perform HT anneal and pre- & postannealing LIV as soon after irradiation as possible
- Absence of RT recovery improves sample "Shelf Life"
